Caltrans Balsi Beam Crash Test & In-Service Issues

(with comparison to Mobile Barriers MBT-1)

Mobile Barriers Calls for the Retirement and Replacement of Caltrans Balsi Beam

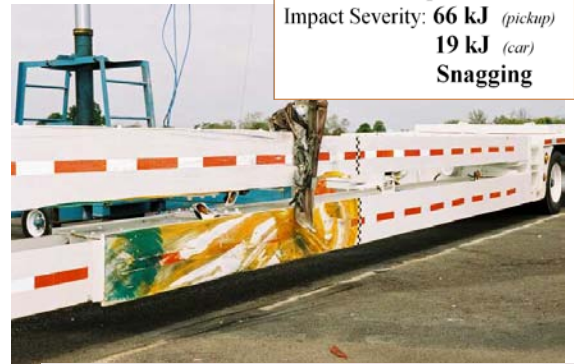
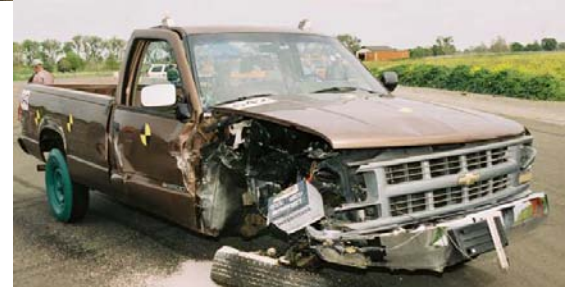
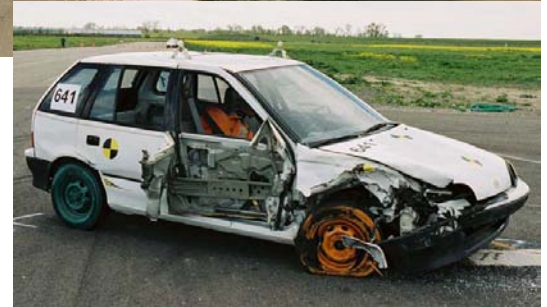
Balsi
 TL-2/350 - 43 mph
 Impact Severity: 66 kJ (pickup)
 19 kJ (car)
Snagging

- Excessive Tearing.** FHWA guidance in 2012 specified that even if all other test evaluation criteria are met, “excessive tearing/shredding to the vehicle exterior” may alone be basis for failure. [See 2012 FHWA Memo, Attachment A, pg 8.](#) Both vehicles in the Balsi tests had extreme tearing/shredding, and at only 43 mph. Beam joints snagged and tore the front quarter panels off both vehicles, and the outer skin off the car to the rear of the passenger door. Separate accounts contradict the report and indicate the Balsi itself was disabled following the impact. The Balsi used in the test was later taken out of service and replaced.

- Inadequate Beam/Wall Height.** The Balsi beams are only 24” high when positioned one to each side. As such they would engage only 4” of bumper on modern pickups and the later would likely jump the beam into the work area. The beams are still only 36” high when both are rotated to one side. That is only about hip high and leaves much of a person’s upper body exposed. It also would not fully brace a modern pickup. The modern heavier pickup required under current TL-3/MASH standards, has a higher center of mass may lean or swing the over the beams. The beams would not even engage the frame of a larger truck. Highly mobile barriers such as the Balsi are intended to be used in tight proximity to workers and traffic. There is no room for override.

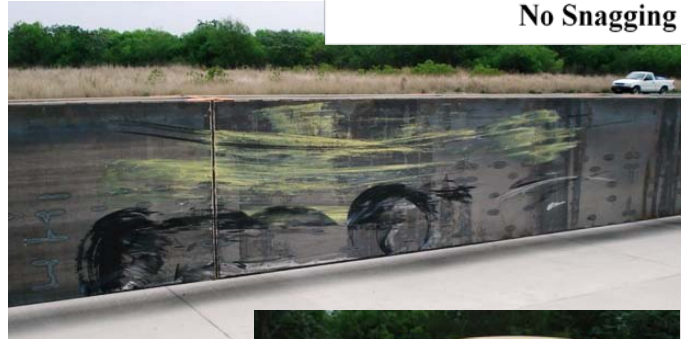
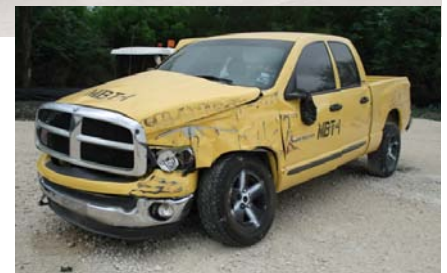
MBT-1
 TL-3/MASH - 63 mph
 Impact Severity: 150 kJ
No Snagging

- The high smooth walls of Mobile Barriers MBT-1 exhibited no snagging or tearing and cleanly turned the crash vehicle. The front quarter panel merely flattened, and no windows broke. The MBT-1 in the crash test was fully functional and is still in service.*

- MASH testing of Mobile Barriers MBT-1 highlighted the need and value of full 5’ walls. Almost all of the height of the walls were used to control and redirect the pickup at the much higher MASH test levels representative of those that may be encountered on an interstate. In two instances where semi-trucks hit MBT-1, the primary engagement was over 36” up the walls. The semi’s would not have even engaged the Balsi beams. The 5’ height of MBT-1’s walls have proven critical in its handling of errant vehicles. See MBT-1 [Crash Photos](#) and [Crash Video](#).*

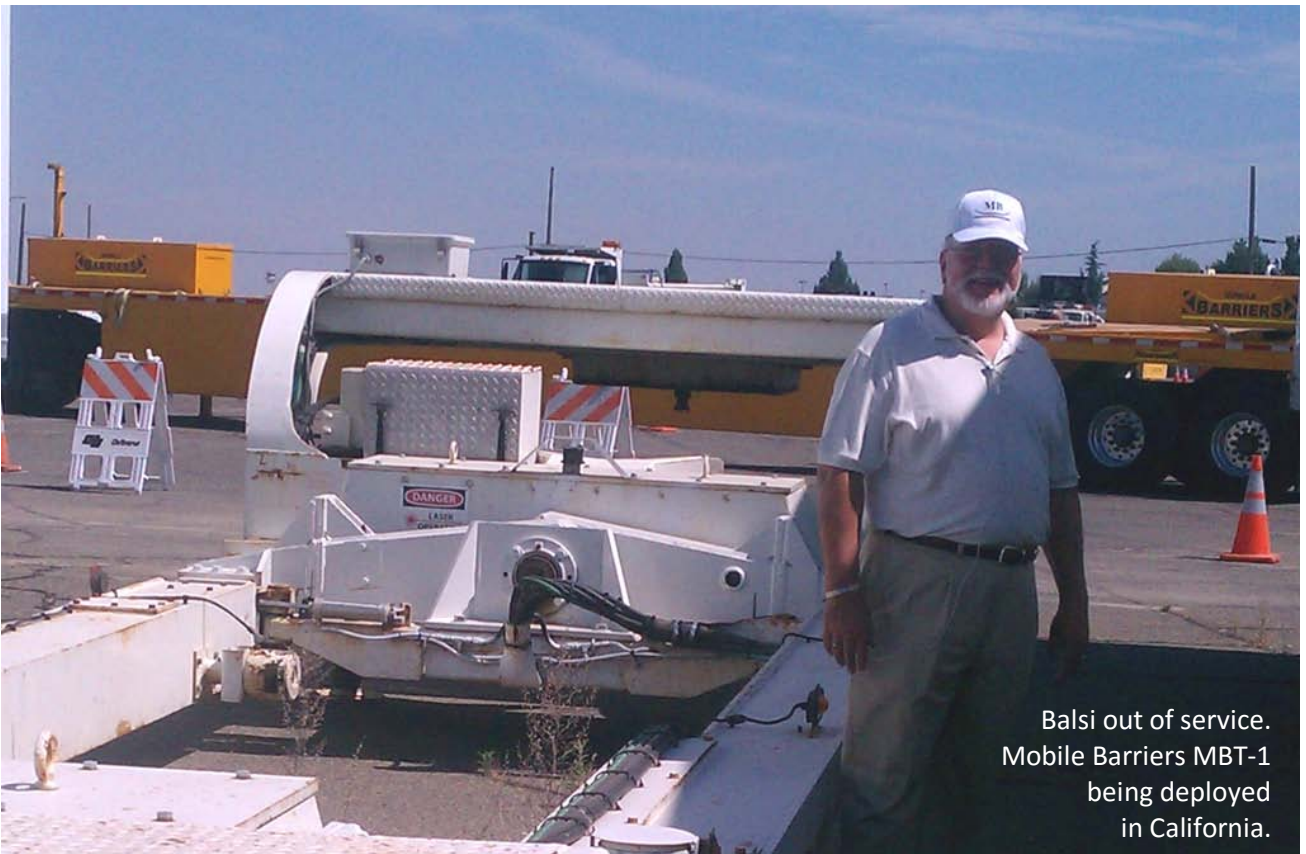
Balsi out of service.
Mobile Barriers MBT-1
being deployed
in California.

- **In-Service Issues.** The Balsi has a lot of moving parts. The rotating beams require on-site setup on arrival and departure to deploy jack stands, stabilize the unit, and rotate the arms. Jack stands required to stabilize the unit preclude use for mobile operations. Loads cannot be carried on the decks as the unit becomes unbalanced and tends to bind and lock up. To rotate the beams, the ends must be precisely aligned. The jointed beams rotate on a single center pivot and any misalignment or play in the joints can cause the unit to bind and lock up. There are a complex array of chains and hydraulics throughout the Balsi that must all work properly for the unit to function. As a former Caltrans State Equipment Manager noted, it is difficult and expensive to build and maintain. Units have locked up and/or otherwise been disabled when arms did not align, expand/contract or rotate properly, or the hydraulic jacks needed to stabilize the unit fail. Bolt sheer and other issues have been reported. When along the road, such mechanical failure can create a hazard for motorists, that may not be easily removed. Examples of Balsi lockup have been witnessed by third parties on at least two separate occasions. Both visiting parties have acquired Mobile Barriers MBT-1 instead.
