MOBILE BARRIERS MBT-1

“HIGHLY MOBILE, INTEGRATED PROTECTION FOR SHORT TERM WORK ZONES”

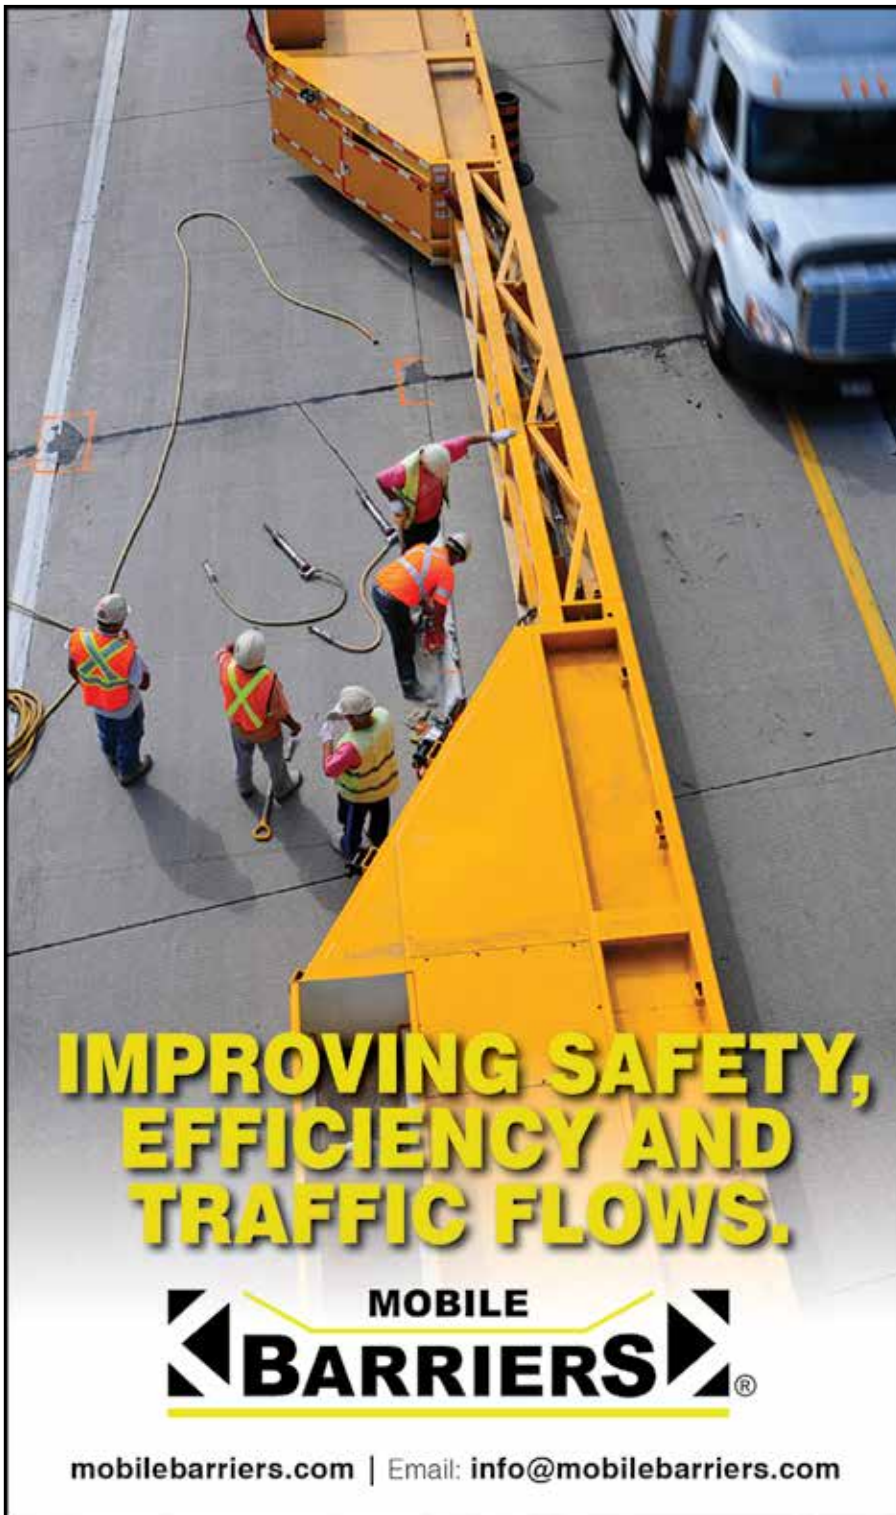
With 5-foot-high walls and integrated power, lighting, signage, and TMA, the barrier can be driven to site with no special setup. The barrier’s storage areas and surface decks can be used to carry tools, equipment, materials, and supplies to and from the jobsite. 30-foot cranes and scissor lifts are two of the newer options which can be added to assist crews.
